U. S. NAVAL ORDNANCE TEST STATION

TECHNICAL PROGRESS REPORT

C12 DETONATOR MALFUNCTIONS IN
EX 1 MOD 0 ILLUMINATING
HAND GRENADE

September 1963

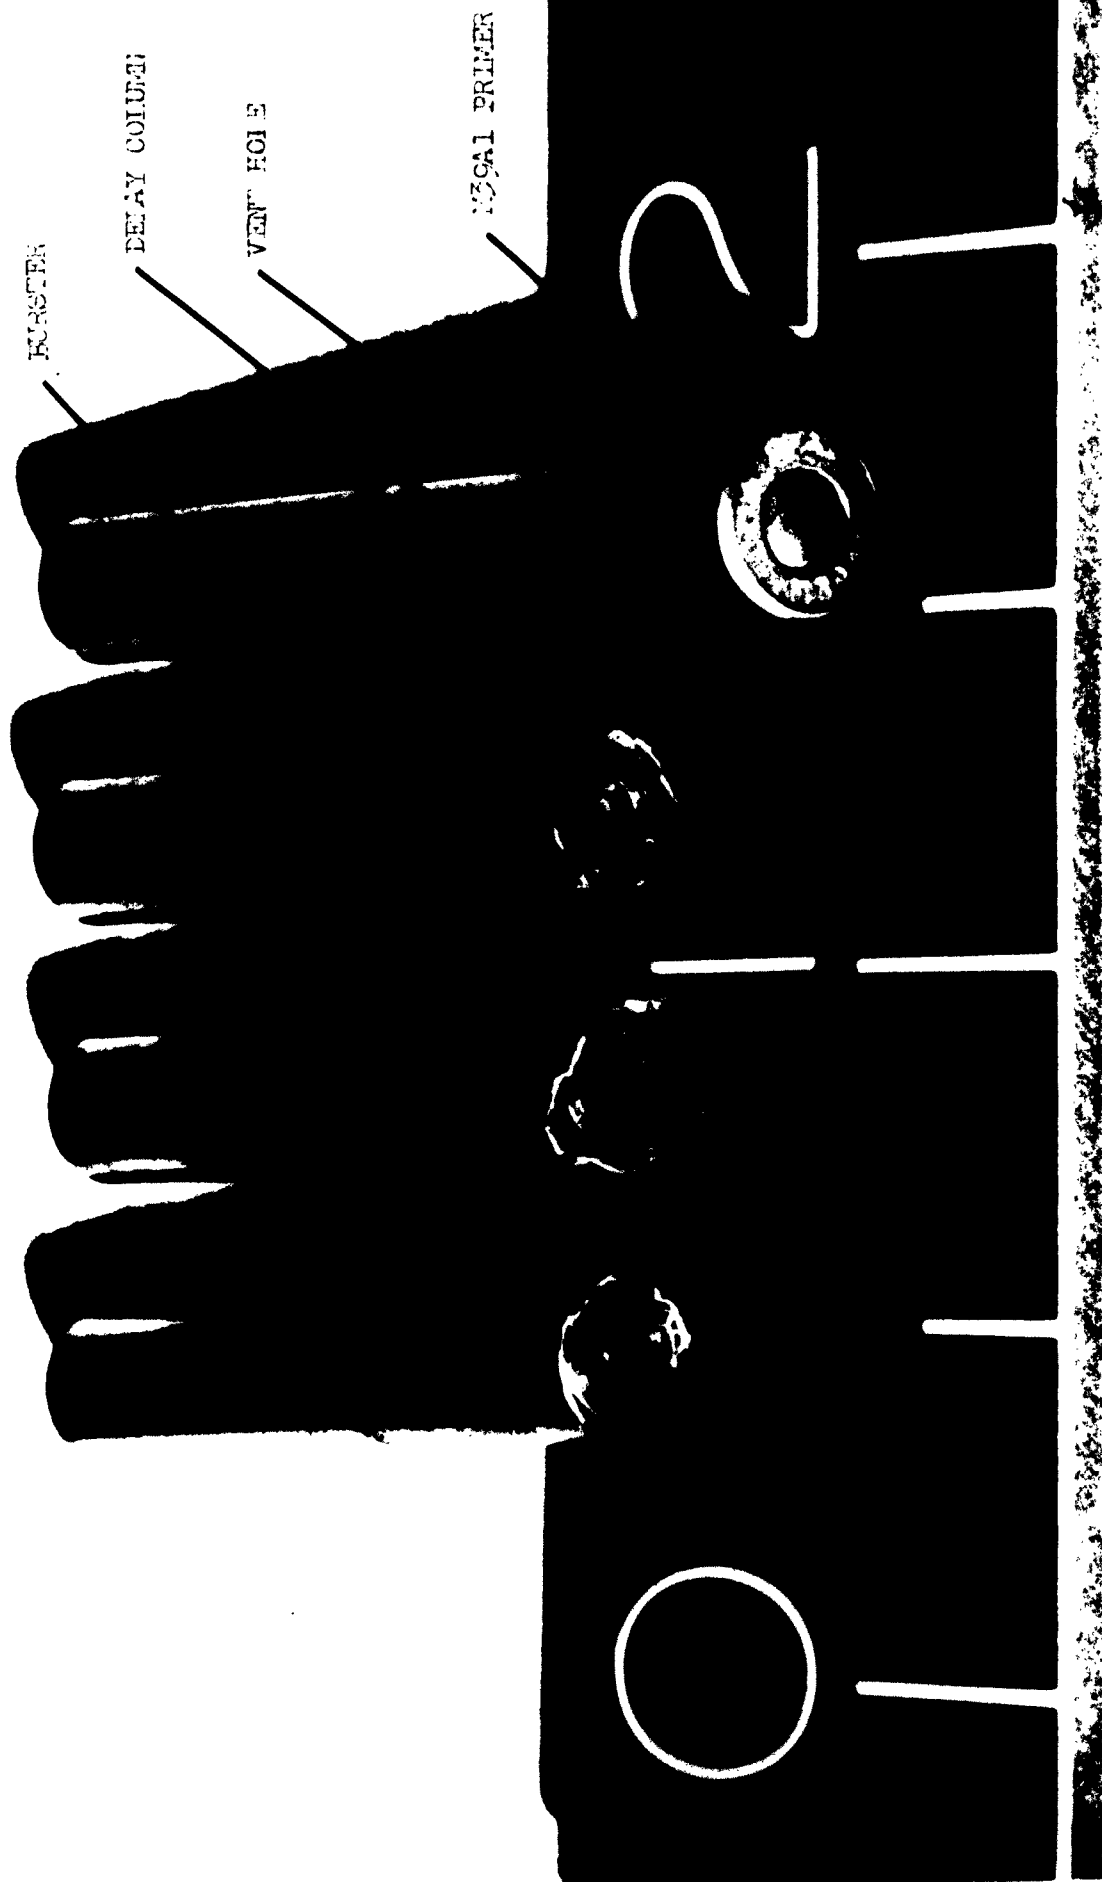
FIGURE 1. C-12 DETONATOR

The four defective detonators were sectioned at the vent. In three the primer had fired, while in the fourth the primer had not fired at all. Figure 1 shows the appearance of the fuze train of detonators in which the primer fired, and also of an unfired primer. Radiographs of a misfired, fired, and unfired primer are shown in Fig. 2.

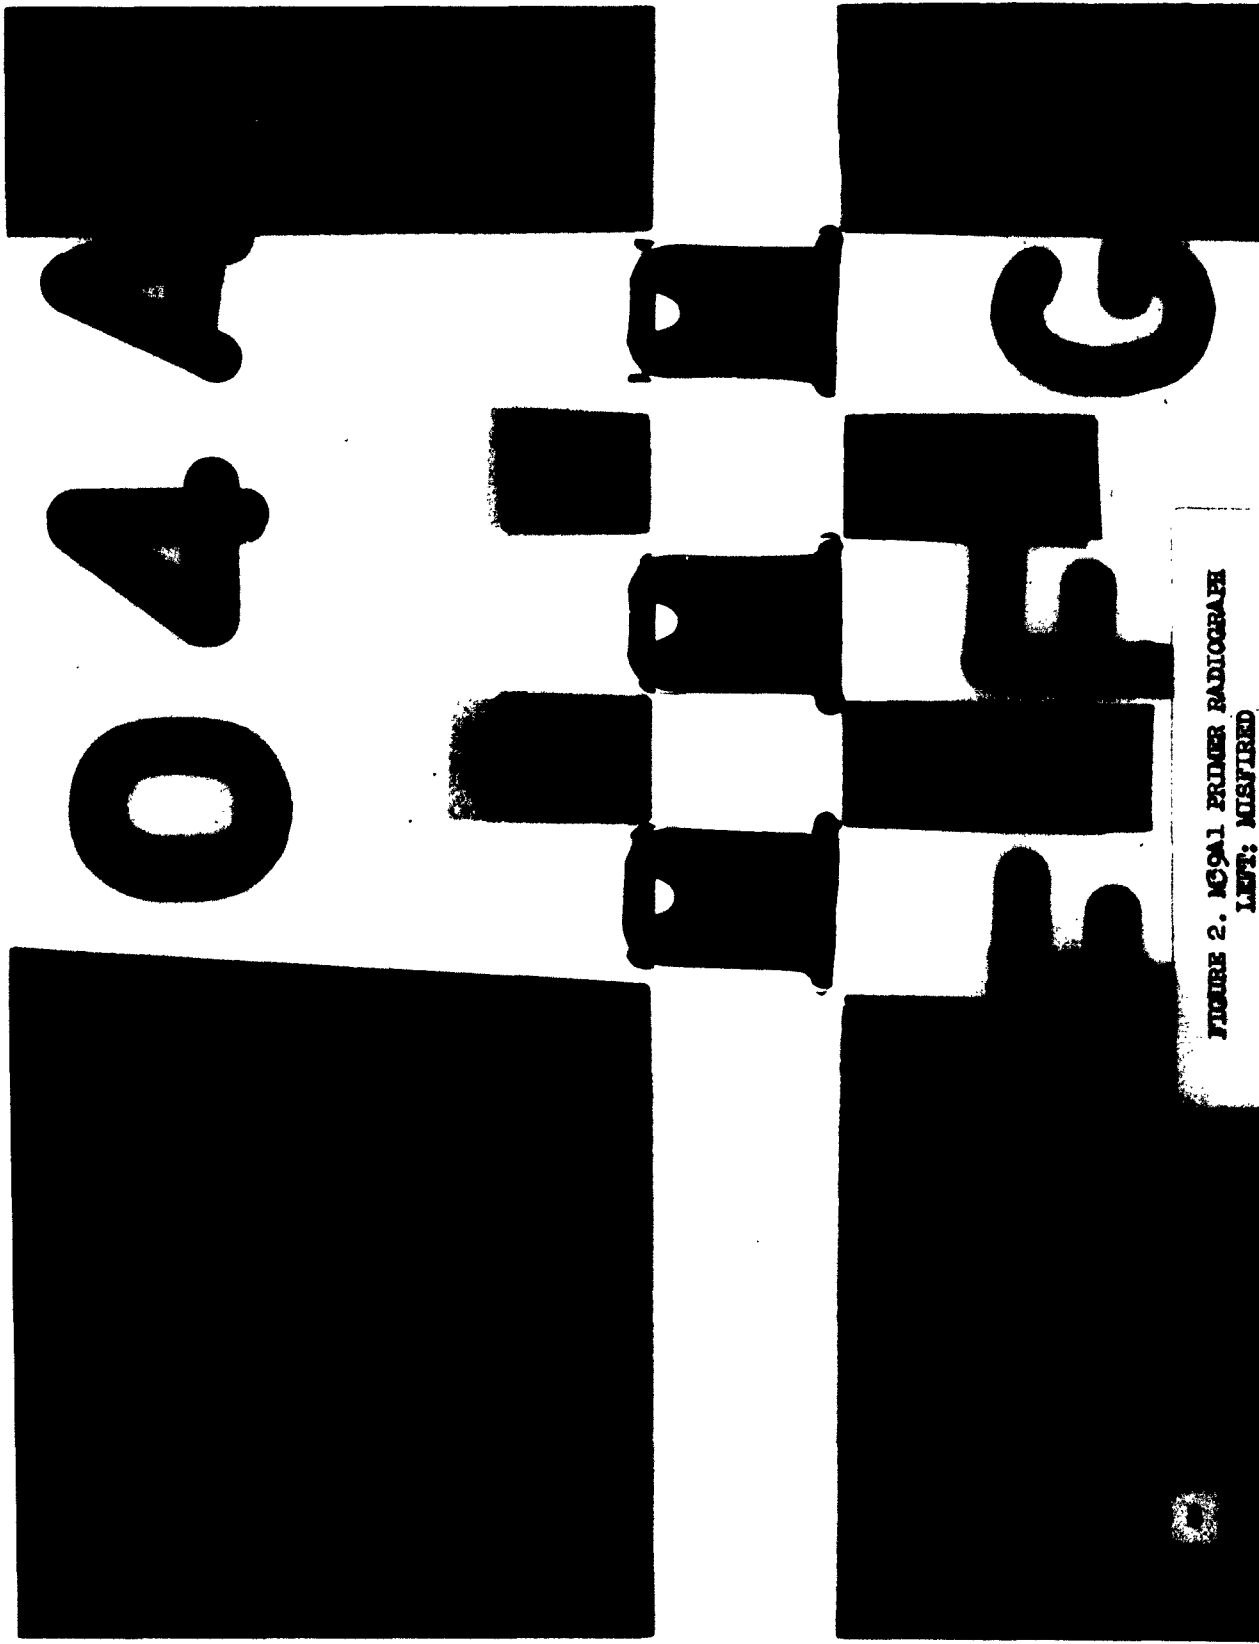
FIGURE 2. M99A1 PRIMER RADIOGRAPH
LEFT: MISFIRED

On 14 February 1963 the Pine Bluff Arsenal reported in response to telephone request that detonator C12, lot OM-1-23, had been found defective, the malfunction being caused by the M39A1 primer used.

The Pine Bluff Arsenal also advised that a new procurement was in process for some 250,000 detonators C12. However, these would be fabricated with a Western Cartridge Company primer, EX 2926A, instead of the M39A1 design. The EX 2926A has a satisfactory service record. This contract was let in June 1963 to Olin Mathieson Company.
